safety alert

Chemical Tank Failure

Alert No: 2 - 2008

Date: August 05 2008

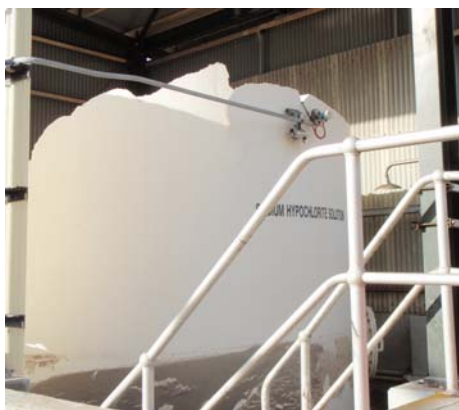
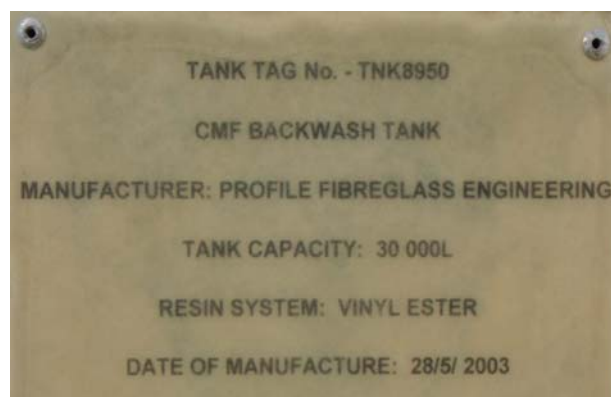
A Sodium Hydrochloride Tank burst spilling the entire contents into the bund area.

The Incident occurred at Wollongong STP and affected Sydney Water personnel, contractors, visitors & the environment.

It has implications for any Sydney Water site that has tanks fabricated by "Profile Fibreglass Engineering" with Manufacturing date approx. 2003.

Plant Managers to conduct a site audit to verify if similar tanks are in operation. If possible tanks should be isolated and taken out of operation with tank contents removed. If this is not possible then an exclusion zone should be set up with barrier fencing and appropriate signage. The exclusion area should be based on the risks associated with the tank's contents, and the consequences if failure should occur. For eg a tank containing sulphuric acid should have an exclusion zone preventing any possible contact with personnel.

Arrangements have been made by plant management at Wollongong to carry out a structural assessment of the failed tank and similarly constructed tanks at the Wollongong STP. Subject to the findings further actions will follow.
